RE: The Settlement at Powhatan Creek, Phase 1

I am writing you today to inform you of the incomplete items for the above referenced project phase. The deficiencies that remain for completion of the project and release of the associated sureties are listed below and are the result of several field inspections, most recently on May 26, 2017.

Post Construction Report

The Settlement at Powhatan Creek

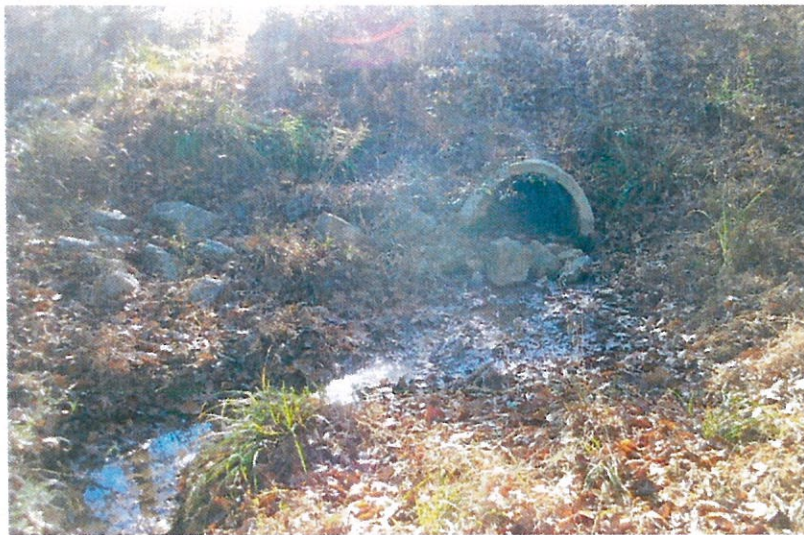
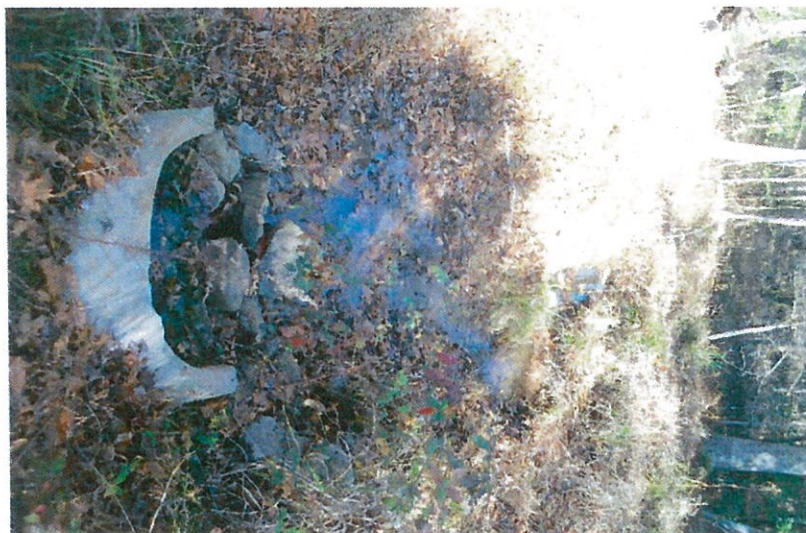
1. The 18" outfall pipe for the facility is lacking the designed riprap apron at the discharge point of this outfall pipe. This apron is shown on the asbuilt drawings; however, the apron has become covered with sediment and vegetation since its construction and must be cleaned and restored to its original design.

- Remediation and repair of rip rap outfall apron area. Repair work is outlined in the LandTech Resources, Inc (LRI) report dated January 1, 2017, page 8.

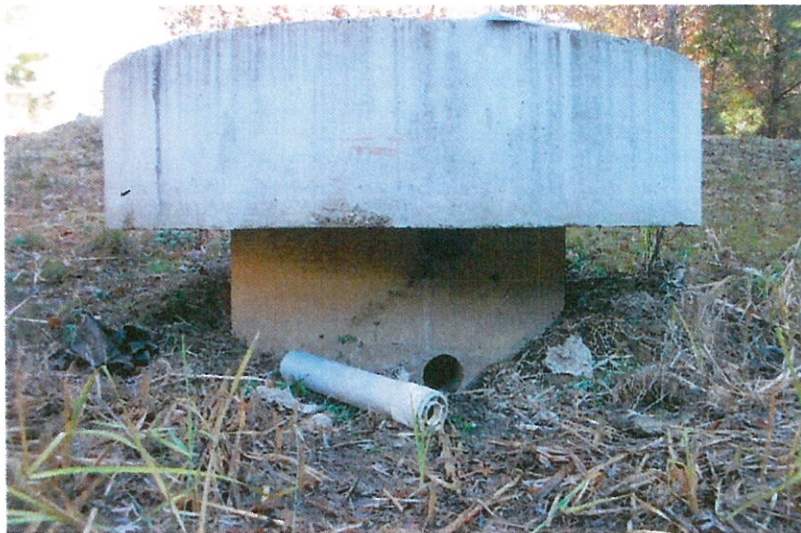
1. The installed riser structure appears to be incorrect. The design of the structure calls for a small diameter low flow orifice, however the riser structure contains multiple circular openings. Contractor should provide a way to permanently seal all openings located in the riser structure that are not called for in the design drawings.
2. The low flow orifice was improperly installed in the riser structure and has failed and become dislodged from the structure. It appears that the low flow pipe was installed with gravel and filter fabric only and must be properly grouted into the existing circular opening in the riser structure to prevent leakage around the exterior of the low flow pipe.

- Repairs for the inflow pipe, the riser and low flow orifice, and the emergency spillway. The majority of the needed work is outlined in the LRI report, pages 9-12. The inflow pipe elevation is nearly equal to the riser outflow elevation, causing water to pool and stagnate along the basin bottom. A remediation plan for this issue must be provided to the Division for approval prior to implementation.

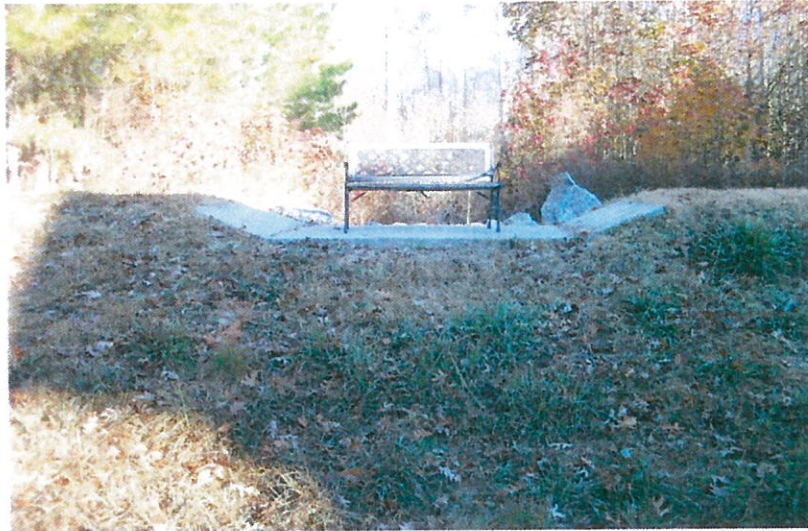
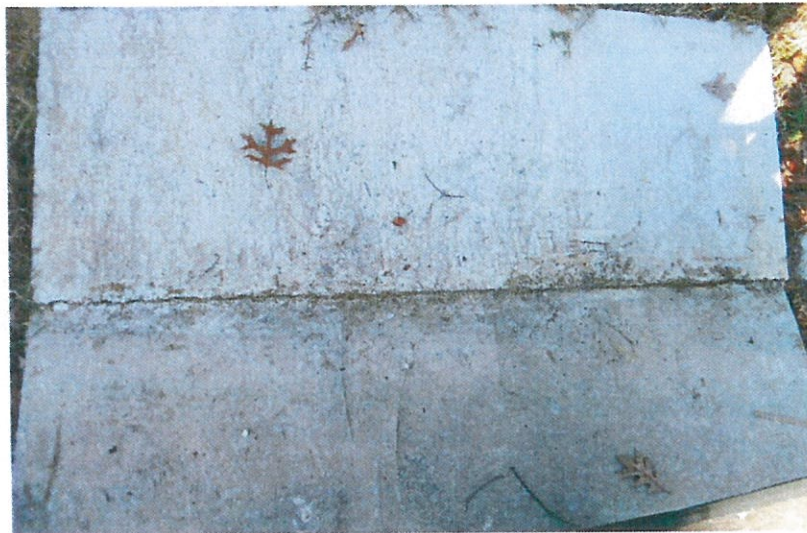
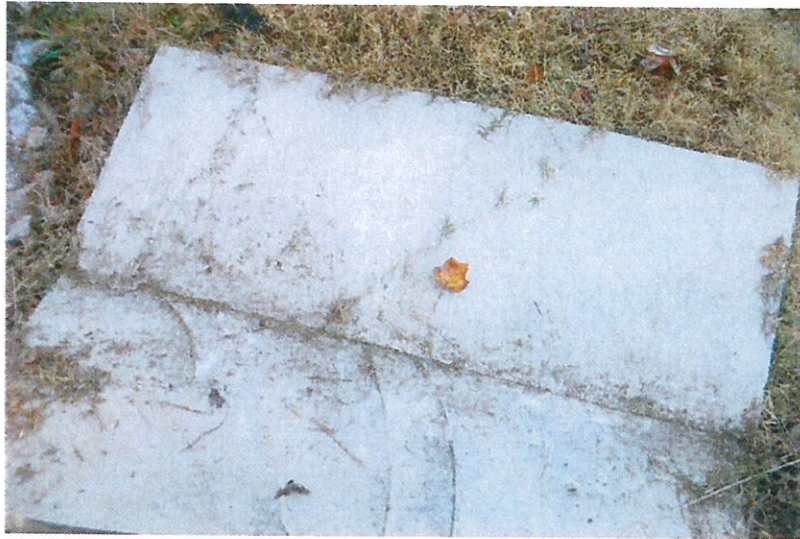
3. The side wings of the concrete emergency spillway have begun to crack and separate away from the control section. The cracks should be cleaned of debris and caulked to prevent water from entering the cracks and causing future failure of the structure.

4. The side wings of the concrete emergency spillway have begun to crack and separate away from the control section. The cracks should be cleaned of debris and caulked to prevent water from entering the cracks and causing future failure of the structure.

- Stabilize bank adjacent to inflow area.
 - Backfill lip along pond side of emergency spillway section. Currently, the embankment is approximately 4" below concrete lip of spillway section which allows water to undermine the spillway section.

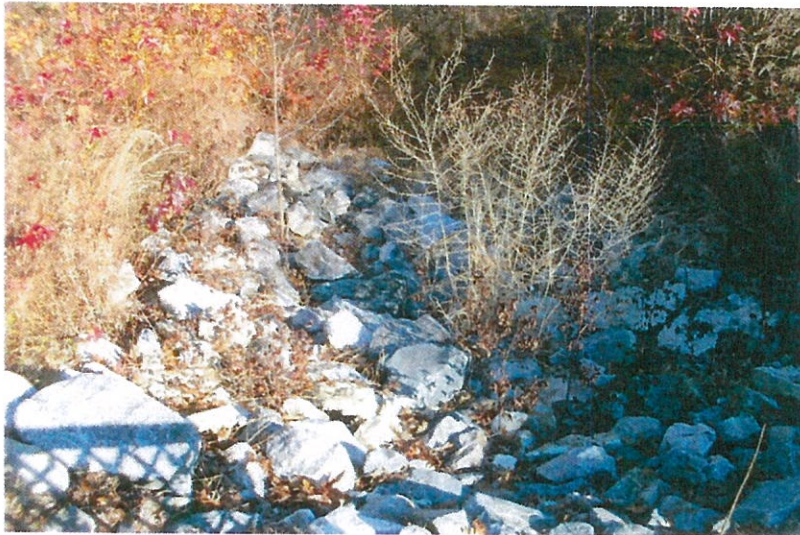
5. The riprap as well as the grass lined channel downstream of the concrete emergency spillway should have all vegetation removed to insure proper drainage during large rainfall events.

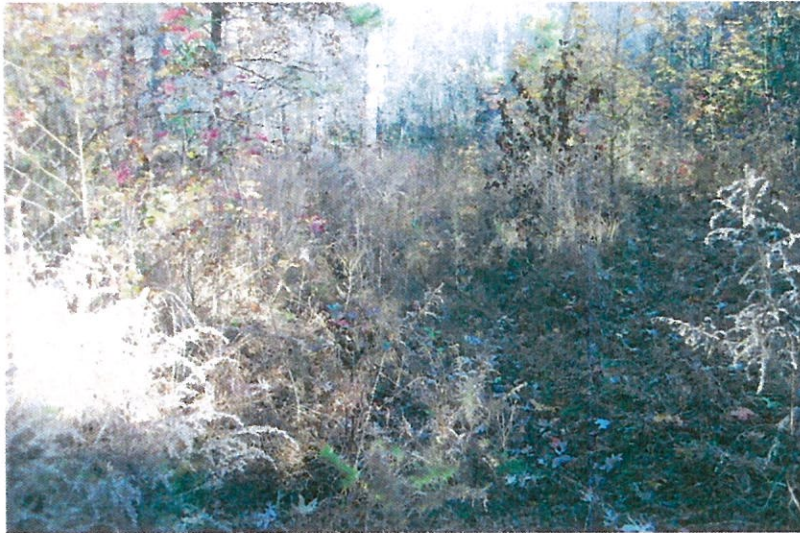
6. The bottom of the BMP has started to grow cattails in certain areas. This vegetation should be properly removed from the BMP and should include the removal of the root mat material below the BMP surface.
7. The riprap apron installed at structure SS #3-1 is not installed per design. The apron is undersized and is lacking the correct amount of material to function properly. The riprap should be removed and the area should be properly regraded and the correct dimension of riprap should be installed per design.
